## Morphological signatures of mass wasting and delta processes in a fjord-lake system: insights from Lovatnet, western Norway

Louise Hansen, Nicolas Waldmann, Joep E.A. Storms, Raymond S. Eilertsen, Daniel Ariztegui, Emmanuel Chapron, Atle Nesje

Louise Hansen, Nicolas Waldmann, Joep E.A. Storms, Raymond S. Eilertsen, Daniel Ariztegui, et al.. Morphological signatures of mass wasting and delta processes in a fjord-lake system: insights from Lovatnet, western Norway. *Norwegian Journal of Geology*, 2016, 96 (3), pp.9-30. hal-01326339

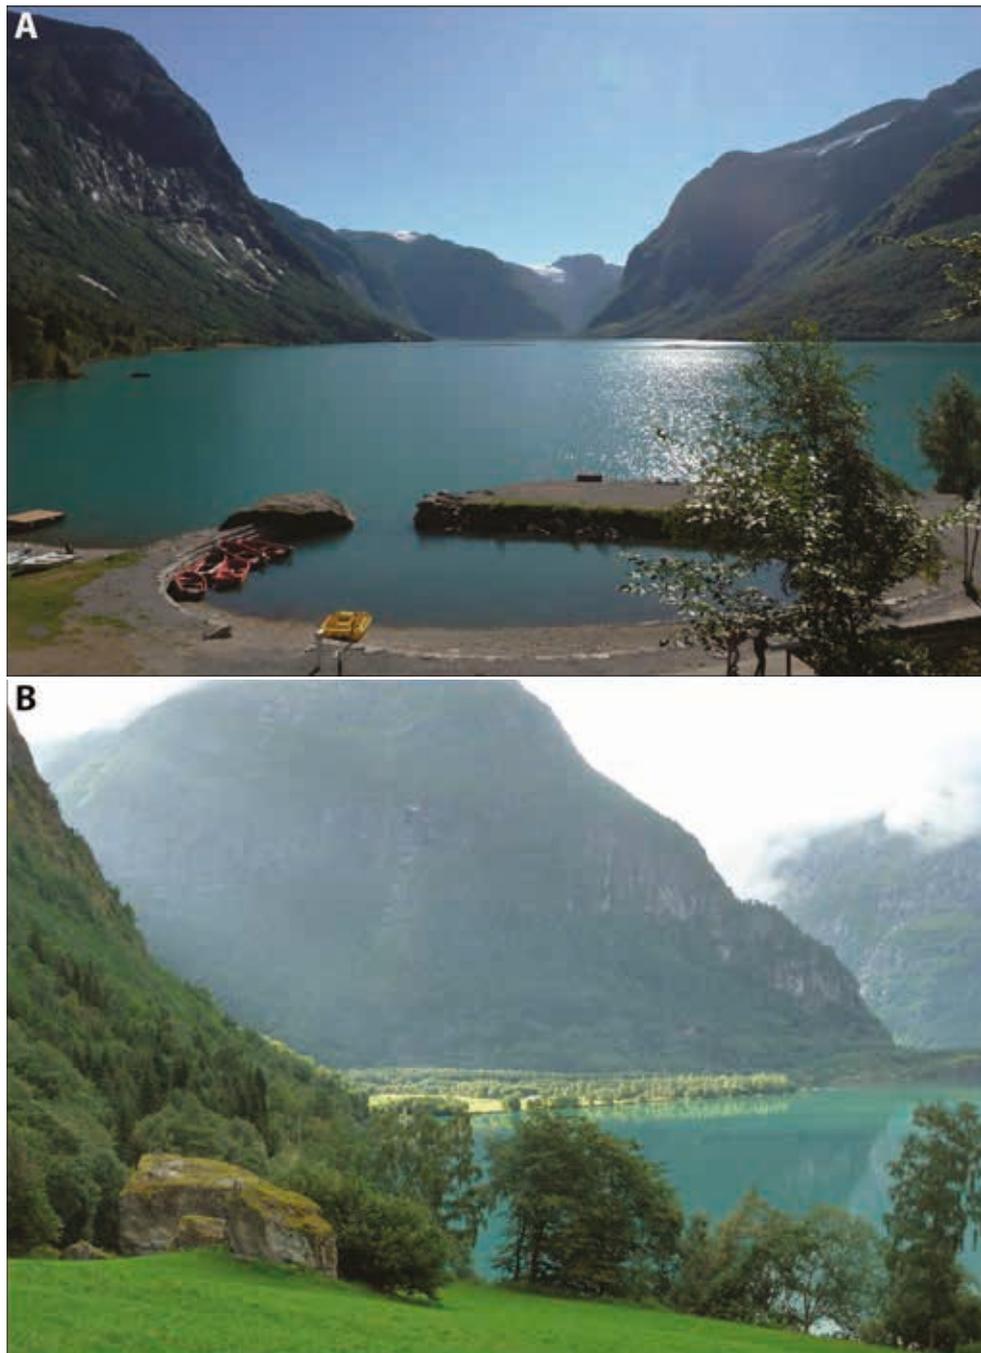
**Figure 3.** (A) View from Sande towards the southeast along Lovatnet. The prominent Hellsetefjellet is shown to the left whereas Ramnefjellet is shown in the middle ground to the right. In the background is the Krunebreen outlet glacier from the Jostedalbreen ice field. (B) View from Raudi towards Bøaøyna (Bødals delta). The huge blocks in the foreground are from the rockfall at Raudi in 1885; see text. Photos: Louise Hansen.

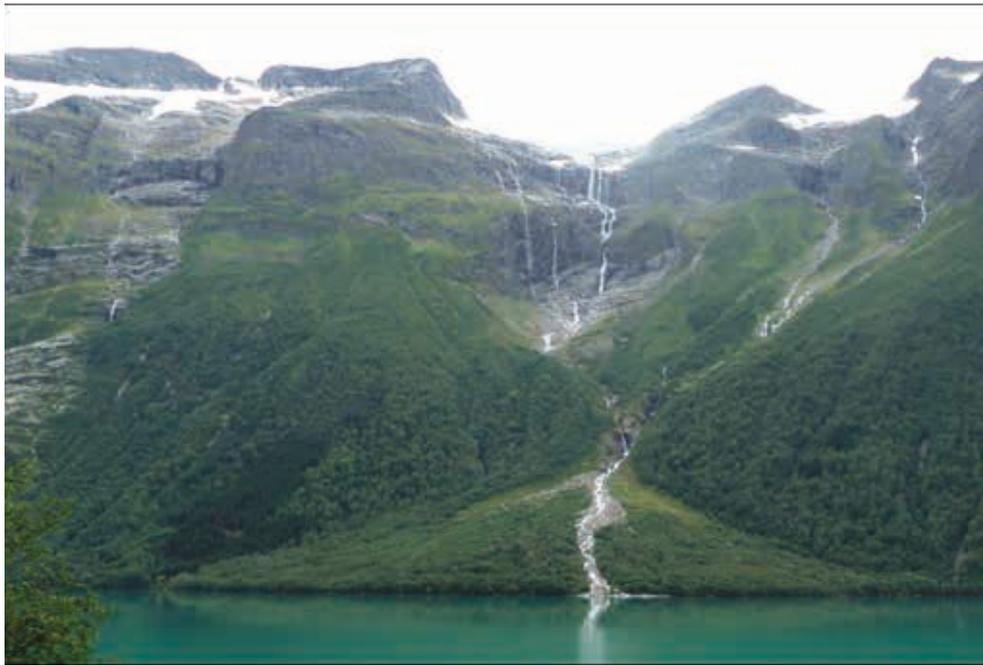
**Figure 4.** View towards Helsetøyna (Helset fan delta) and its catchment with steep bedrock slopes and glaciers. Notice the treeless apex of the fan, which is otherwise densely vegetated with just one active fluvial channel. The water in Lovatnet is bluish in colour during the summer season due to the supply of meltwater. Photo: Louise Hansen.

valleys and steep streams cascade into the lake either directly or via steep fans e.g., at Helsetøyna and the Helset delta (Figs. 2, 4). The Bødalselv river feeds a major, low-angle delta at Bøaøya in the southeastern part of Lovatnet (Bødalsdelta; Fig. 3B). The outlet of Lovatnet at Vassenden drains into Lobukta, one of the innermost arms of the Nordfjorden fjord system near the village of Loen (Fig. 1).
