# Bank re-erosion action to promote sediment supply and channel diversification: Feedback from a restoration test on the Rhine

Valentin Chardon, Laurent Schmitt, Anne Clutier

**Keywords:** Large river restoration, bank re-erosion, transverse groynes, geomorphological monitoring, management guidelines, Rhine river

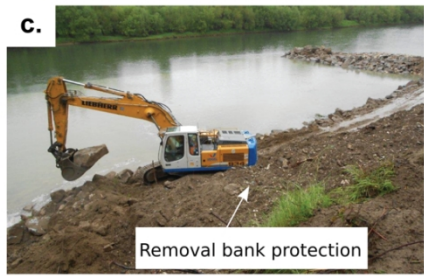
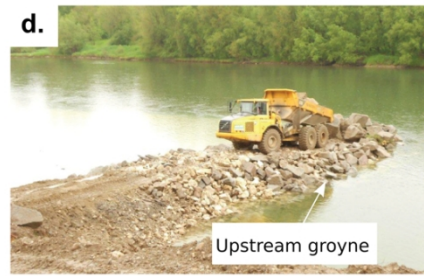
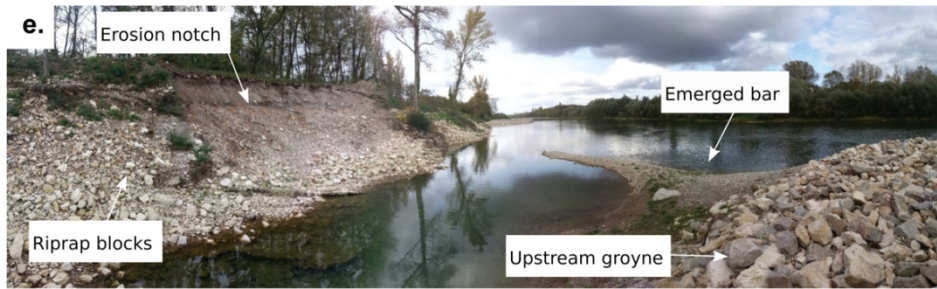
38  
39 39 Figure 1. a. The Rhine Basin; b. locations of the Old Rhine, Grand Canal d'Alsace (GCA),  
40 40 dams, power plants and restoration site; c. removal of bank protection; d. groyne  
41 41 construction; and e. channel responses after the flood of May-June 2013 (left bank re-  
42 42 erosion and sediment deposition downstream of the upstream groyne; the view is in the  
43 43 downstream direction).  
44  
45

21 length of 300 m and removing three old groynes (almost 1 century old; Fig. 1). Additionally,  
22 two new transverse groynes were implemented to maximize bank re-erosion (Fig. 1d). The  
23 best locations and shapes of these groynes to favour bank re-erosion were determined  
24 prior to field work from numerical and physical modelling (Die Moran, 2012).  
25 These studies showed that the groynes should be placed perpendicular to the bank and  
26 disconnected from it, with a length equal to 30 m.  
27 Geomorphological monitoring was undertaken according to the before-after framework  
28 based on five states (Si) and four periods (Pi) (Fig. 2). The instantaneous peak flow  
29 estimated at the Rheinweiler gauging station (Fig. 1.b) was  $3,070 \text{ m}^3 \cdot \text{s}^{-1}$  ( $Q_{ix} = 15$  years),  
30  $1,910 \text{ m}^3 \cdot \text{s}^{-1}$  ( $Q_{ix} \approx 5$  years),  $1,880 \text{ m}^3 \cdot \text{s}^{-1}$  ( $Q_{ix} \approx 5$  years), and  $2,010 \text{ m}^3 \cdot \text{s}^{-1}$  ( $Q_{ix} \approx 5$  years)

49 whose size exceeds the river competence (the whole length of 300 m is considered; Fig.

1  
2 1 1.e); (ii) local outcrops of Pleistocene coarse pudding sediment located in the bank  
3 2 foot (Fig. 1.e); (iii) excessively weak local hydraulic conditions despite the presence of  
4 3 groynes; and (iv) the progressive vegetation growth of the bank that began since P2.  
5 4 These results show that the management action provided no significant bank re-erosion,  
6 5 which invalidates our first hypothesis.

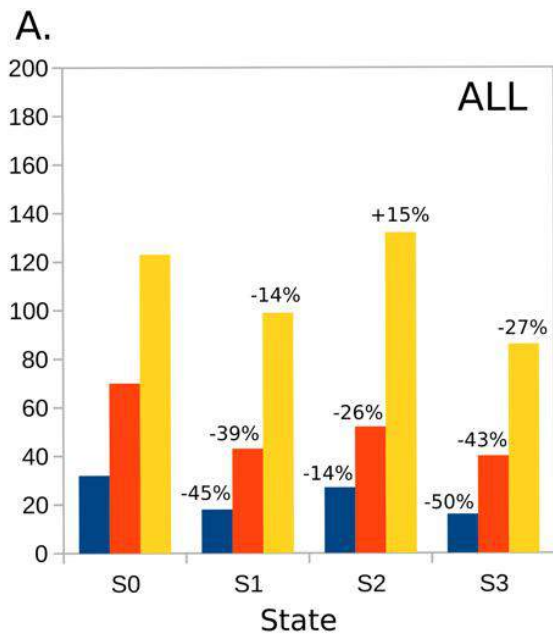
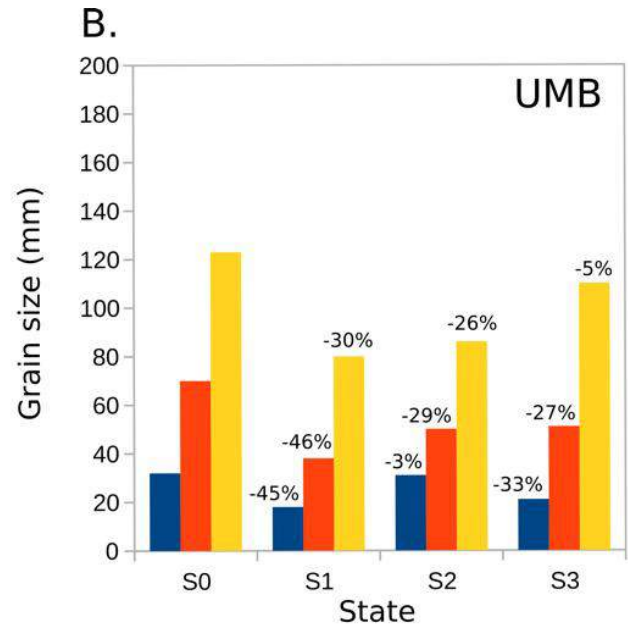
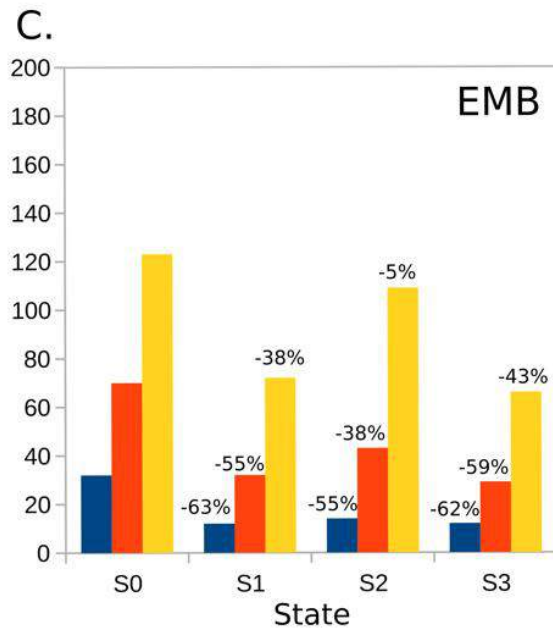
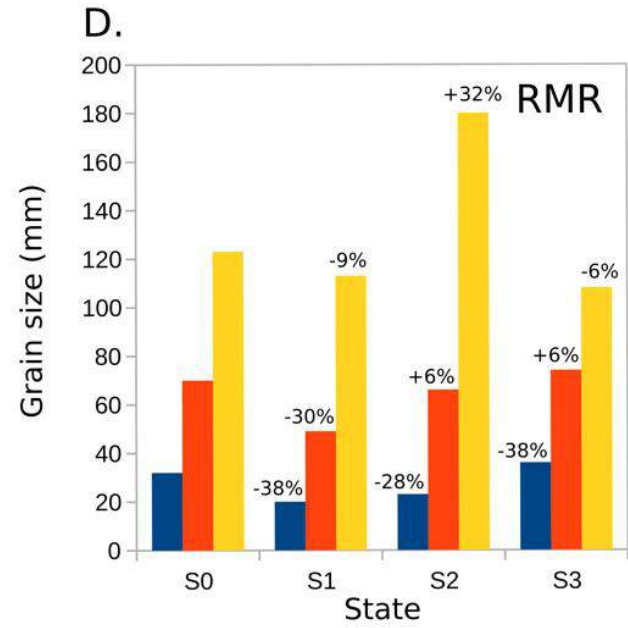
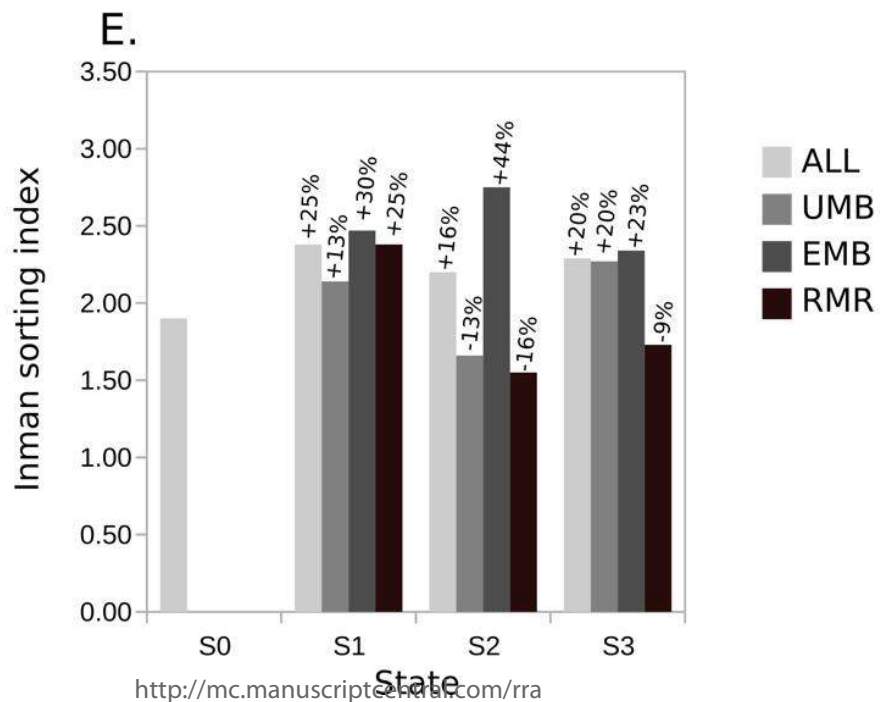
30  
 31 Figure 6. Temporal grain-size evolution of the whole study reach (ALL; A.), the mid-  
 32 channel bars in underwater conditions (UMB; B.), the mid-channel bars in emerged  
 33 conditions (EMB; C.), the remaining monitored reach (RMR; D.) and evolution of the  
 34 Inman-sorting index for each condition (E.). Percentages at each state were calculated by  
 35 comparing the corresponding grain size with the grain size at S0. The sorting index was  
 36 calculated following the equation proposed by (Inman, 1952) .

20 The bed grain-size monitoring showed that the restoration induced grain-size refinement  
 21 and diversification in comparison with the pre-restoration data (Fig. 6). The grain-size  
 22 refinement reached 29 mm ( $D_{50}$ ; -59%) for the gravel bars in above-water conditions  
 23 (EMB) during P3 and 38 mm ( $D_{50}$ ; -46%) during P1 for the gravel bars in underwater  
 24 conditions (UMB). Grain-size diversification also occurred, with an increase of +44% in the  
 25 Inman-sorting index during P2 for the EMB and +20% during P3 for the UMB. Grain-size  
 26 changes in both the EMB and UMB were sustainable during the entire monitoring period  
 27 (Fig. 6). On the other hand, grain-size fining and diversification on the remaining monitored  
 28 reach (RMR) during P1 and P2 were transitory. During S3, the grain-size conditions of this  
 29 part of the reach were comparable to the pre-restoration conditions (S0; Fig. 6)
