Bank re-erosion action to promote sediment supply and channel diversification: Feedback from a restoration test on the Rhine

Valentin Chardon, Laurent Schmitt, Anne Clutier

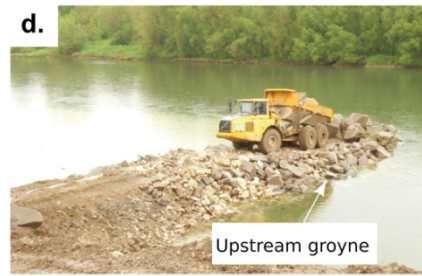
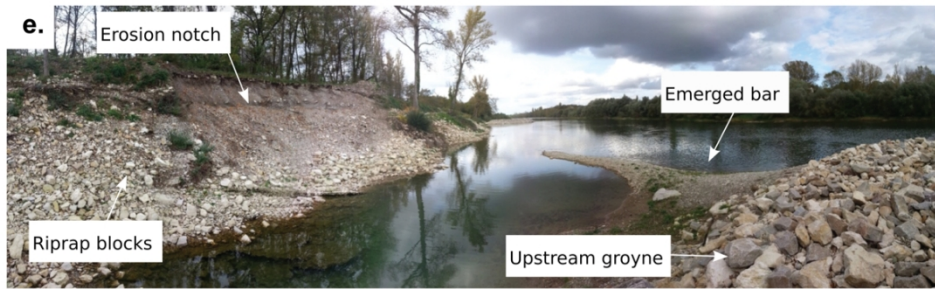
38
39 39 Figure 1. a. The Rhine Basin; b. locations of the Old Rhine, Grand Canal d'Alsace (GCA),
40 40 dams, power plants and restoration site; c. removal of bank protection; d. groyne
41 41 construction; and e. channel responses after the flood of May-June 2013 (left bank re-
42 42 erosion and sediment deposition downstream of the upstream groyne; the view is in the
43 43 downstream direction).
44
45

21 length of 300 m and removing three old groynes (almost 1 century old; Fig. 1). Additionally,
22 two new transverse groynes were implemented to maximize bank re-erosion (Fig. 1d). The
23 best locations and shapes of these groynes to favour bank re-erosion were determined
24 prior to field work from numerical and physical modelling (Die Moran, 2012).
25 These studies showed that the groynes should be placed perpendicular to the bank and
26 disconnected from it, with a length equal to 30 m.
27 Geomorphological monitoring was undertaken according to the before-after framework
28 based on five states (Si) and four periods (Pi) (Fig. 2). The instantaneous peak flow
29 estimated at the Rheinweiler gauging station (Fig. 1.b) was $3,070 \text{ m}^3 \cdot \text{s}^{-1}$ ($Q_{ix} = 15$ years),
30 $1,910 \text{ m}^3 \cdot \text{s}^{-1}$ ($Q_{ix} \approx 5$ years), $1,880 \text{ m}^3 \cdot \text{s}^{-1}$ ($Q_{ix} \approx 5$ years), and $2,010 \text{ m}^3 \cdot \text{s}^{-1}$ ($Q_{ix} \approx 5$ years)

1
2 1 1.e); (ii) local outcrops of Pleistocene coarse pudding sediment located in the bank
3 2 foot (Fig. 1.e); (iii) excessively weak local hydraulic conditions despite the presence of
4 3 groynes; and (iv) the progressive vegetation growth of the bank that began since P2.
5 4 These results show that the management action provided no significant bank re-erosion,
6 5 which invalidates our first hypothesis.

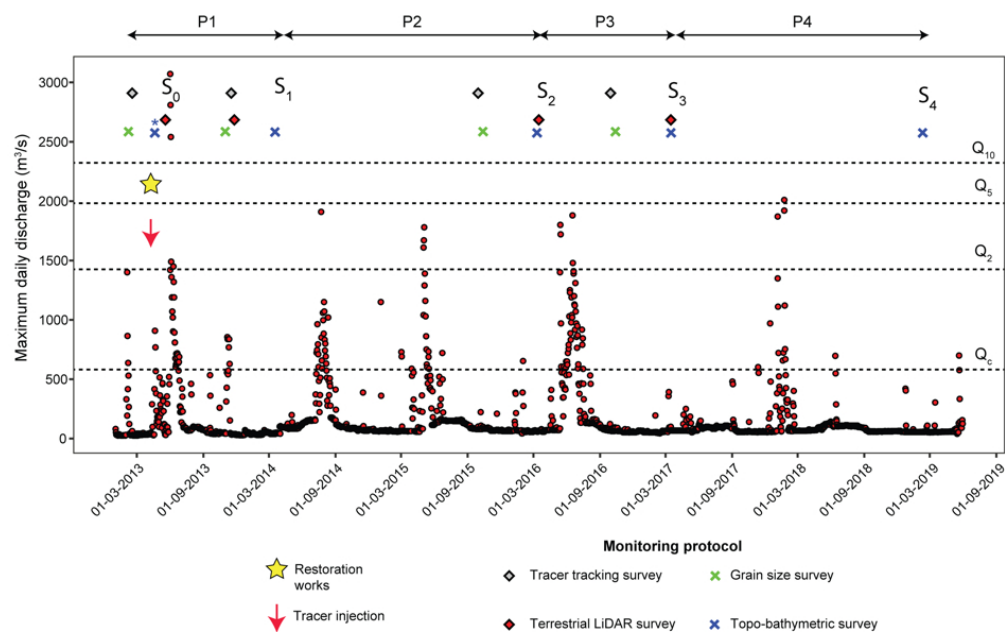
32
33 Figure 2. Monitoring framework and maximum daily discharges recorded at the
34 Rheinweiler gauging station in the Old Rhine.

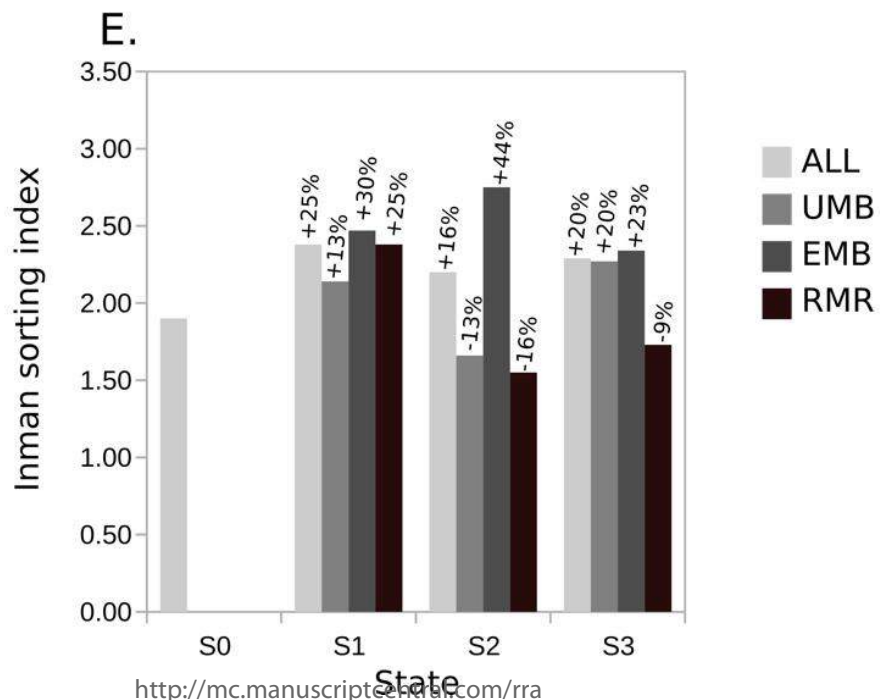
30
 31 Figure 6. Temporal grain-size evolution of the whole study reach (ALL; A.), the mid-
 32 channel bars in underwater conditions (UMB; B.), the mid-channel bars in emerged
 33 conditions (EMB; C.), the remaining monitored reach (RMR; D.) and evolution of the
 34 Inman-sorting index for each condition (E.). Percentages at each state were calculated by
 35 comparing the corresponding grain size with the grain size at S0. The sorting index was
 36 calculated following the equation proposed by (Inman, 1952) .

20 The bed grain-size monitoring showed that the restoration induced grain-size refinement
 21 and diversification in comparison with the pre-restoration data (Fig. 6). The grain-size
 22 refinement reached 29 mm (D_{50} ; -59%) for the gravel bars in above-water conditions
 23 (EMB) during P3 and 38 mm (D_{50} ; -46%) during P1 for the gravel bars in underwater
 24 conditions (UMB). Grain-size diversification also occurred, with an increase of +44% in the
 25 Inman-sorting index during P2 for the EMB and +20% during P3 for the UMB. Grain-size
 26 changes in both the EMB and UMB were sustainable during the entire monitoring period
 27 (Fig. 6). On the other hand, grain-size fining and diversification on the remaining monitored
 28 reach (RMR) during P1 and P2 were transitory. During S3, the grain-size conditions of this
 29 part of the reach were comparable to the pre-restoration conditions (S0; Fig. 6)
