## Lightning damage assessment into composite based on surface explosion and fiber breakage

Audrey Bigand, Christine Espinosa, Jean-Marc Bauchire, Franck Flourens, Frederic Lachaud

Audrey Bigand, Christine Espinosa, Jean-Marc Bauchire, Franck Flourens, Frederic Lachaud. Lightning damage assessment into composite based on surface explosion and fiber breakage. 22nd International Conference On Composite Materials (ICCM22), Aug 2019, Merlbourne, Australia. pp.1-11. hal-02392778

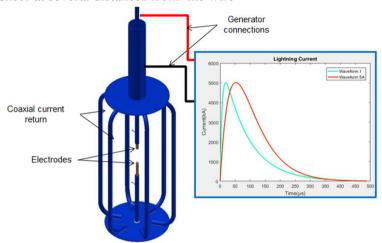
Figure 6 Wire explosion test set up

waveforms have been considered. The first one is WF1 with a time to peak of  $18\mu s$  and a time to half the peak of  $84\mu s$ . The second one is WF5A with a time to peak of  $54\mu s$  and a time to half the peak of  $142\mu s$ . Those waveforms are slower than in the standard due to the impedance of our test set up. To support the study, several measurements have been performed:

- Current
- Voltage
- Picture at vaporization
- Pressure sensor at several distances from the wire

From pressure measurements at different distances and with different amplitudes and lightning waveforms, an experimental law was created to obtain the maximum pressure  $\Delta P^+$  at the wire boundary taking into account the damping effect of the air:

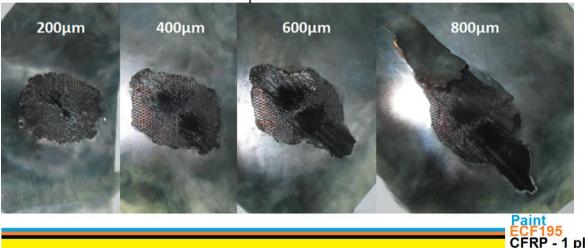
Figure 13 CFRP Current injection with paint thickness increase

Indeed, because of the presence of the paint, the lightning arc can't move freely and part of his current will be injected into the first plies of CFRP, left unprotected by the vaporization of the protection. The more the paint thickness increase, the more the current is injected into CFRP. In the Figure 13 below is presented the result of lightning strike test (100kA) on GFRP panel covered with one ply of CFRP (-45°), ECF195 and several paint thicknesses: 200, 400, 600 and 800µm. Dry fiber is the evidence of current injection into the CFRP ply which heated quickly due to Joule effect. With 200µm of paint, the CFRP ply is almost not damage and, on the opposite, with 800µm of paint, the fibers (-45°) are dry in the center and started to disbond from the panel.

Still, the profile of vaporized ECF is not significantly changed which means this is a very amount of the total current is sufficient to explode the carbon fibers and the resin around.

In order to assess the damage to the composite fibers due to current injection, a specific test set up has been built. The panel configuration shown in Figure 13 is used to measure the damage in one ply f CFRP. Due to the high luminosity of the electrical arc, it is almost impossible to record the vaporization profile of the LSP. The method developed uses the transparency of the fiberglass panel and a high speed camera (1Mfps) placed on the rear face of the panel to record this vaporization profile as shown in Figure 15.

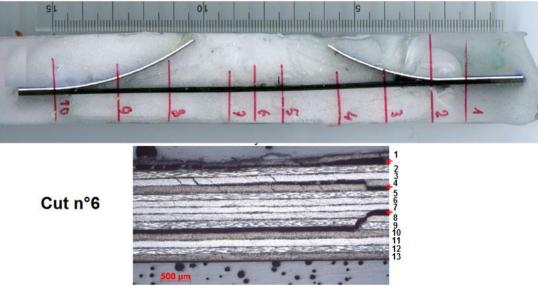
Figure 14 CFRP panel cross section

If we look at a cross section of a full CFRP panel, protected with ECF195 and painted with 400µm of paint, this is the first top ply (among 13 plies) that is mainly damaged by current injection.
