Effects of pulsed laser and electron-beam irradiation on protected aeronautical CFRP composite laminate to enhance the modelling of lightning-strike damage

Bryan Better, M. Arrigoni, Michel Boustié, Serge Guetta, Aboulghit El Malki Alaoui, Chabouh Yazidjian, Nathan Menetrier, Didier Zagouri, Christian Jochum, Gilles Le Morvan, et al.

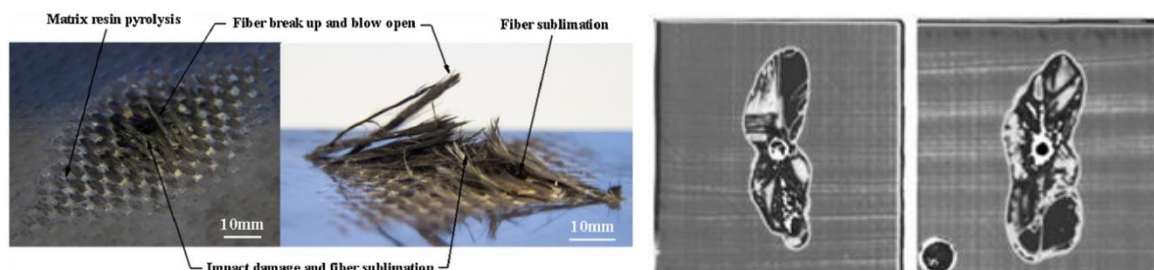
Figure 1 Surface [2] and core [3] damage of lightning strike on CFRP.

Lightning strikes airplanes at an average rate of once or twice per year per plane [1] leading to damage on the airplane hull requiring an extended period of time to repair. Lightning strike involves complex interlinked mechanical, thermal and magnetic phenomena. Thus, the current understanding of lightning strike physics fails to create models able to reproduce the damage produced by the lightning arc on Carbon Fiber Reinforced Plastic composite laminates, especially when a paint coating increases the damage dealt to the composite laminate due to the sublimation of the Lightning Strike Protection. However, the experimental damage observed with lightning strike on composite laminates is mainly composed of core and surface damage [2][3] as seen in Figure 1.

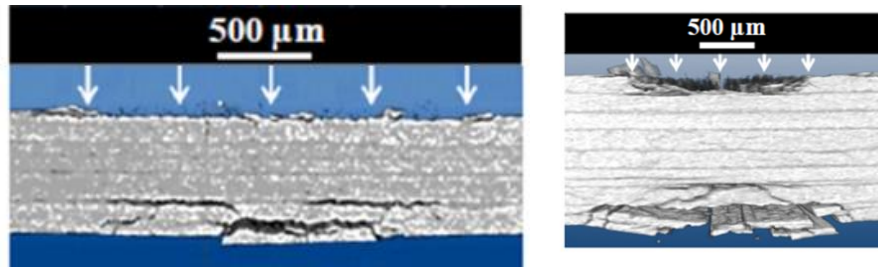
Figure 2 Typical damage produced by laser shock on CFRP composite laminate at low intensity (left) and very high intensity (right). [4]

These damages seem to share some similarities with the damage observed with laser shock [4] and electron beam as seen in Figure 2 and Figure 3.

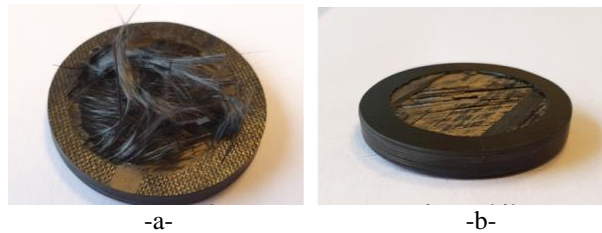
Figure 3 Typical damage produced by electron beam on 35 mm diameter CFRP laminate. -a-: Front face, explosion. -b-: Back face spalling.

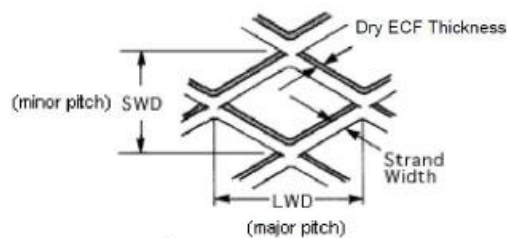
Figure 4 Shape of the Lightning Strike Protection : Expanded Copper Foil 195 (ECF195). Surface density = 195 g.m⁻², SWD = 1.23 mm, LWD = 2.54 mm, thickness = 76 μm, wire thickness = 178 μm. [1]

The aeronautic Composite Fiber Reinforced Plastic composite laminate of interest is composed of 13 plies of 127 μm thickness following the stacking sequence $[45/-45/90/45/-45/0/90_0.5]_s$ [1]. On the front face lays an Expanded Copper Foil (ECF195) which is made from a unique punctured copper foil that is then expanded. This ECF is coated in resin and topped by a 400μm thick aeronautic nonconductive white paint. The ECF dimensions as well as a cross-section view of a sample are shown in Figure 4 and Figure 5.

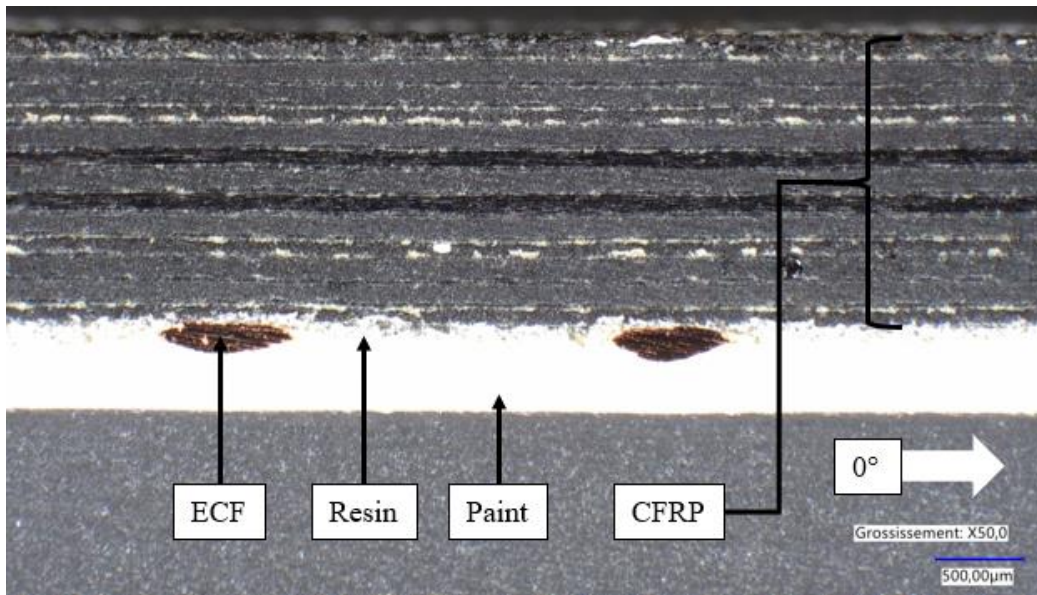
Figure 5 Cross section view of the CFRP coated with ECF and paint. Picture taken with a digital microscope with a magnification factor of 50.

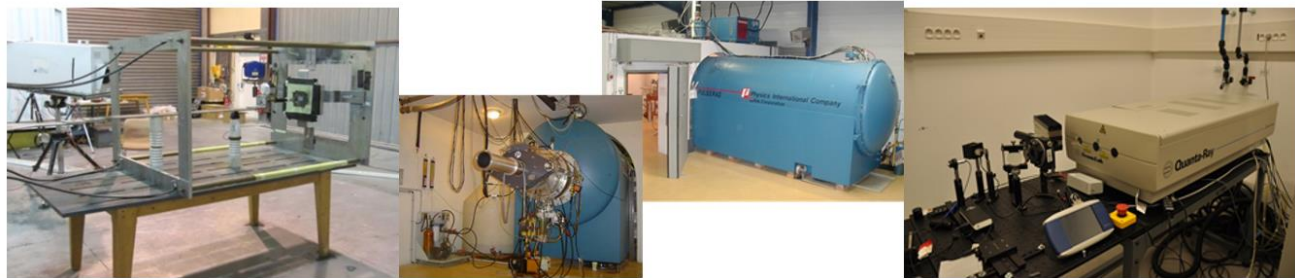
Figure 6 EMMA Lightning strike facility (left) [1], STAEL electron gun facility (middle), BELENOS laser facility (right).

The 2020 campaign was conducted using the EMMA lightning generator of the “Direction Générale de l’Armement Techniques aéronautiques (DGA Ta, Balma, France)” facility. The sizing strike wave is defined by a peak current (100 kA), duration (20µs) and its action integral ($2.5 \cdot 10^5 \text{ A}^2\cdot\text{s}$) [1]. As the lightning arc path cannot be fully controlled, a copper wire is tied to the electrode to guide the current near the target. A lightning arc is produced as the current propagates through the wire before connecting to the target. The target is a 42*42 cm² CFRP+ECF plate coated with 400µm of paint on a 30*30 cm² area. Contrary to the Figure 6, the target was placed horizontally to account for the gravitational force.

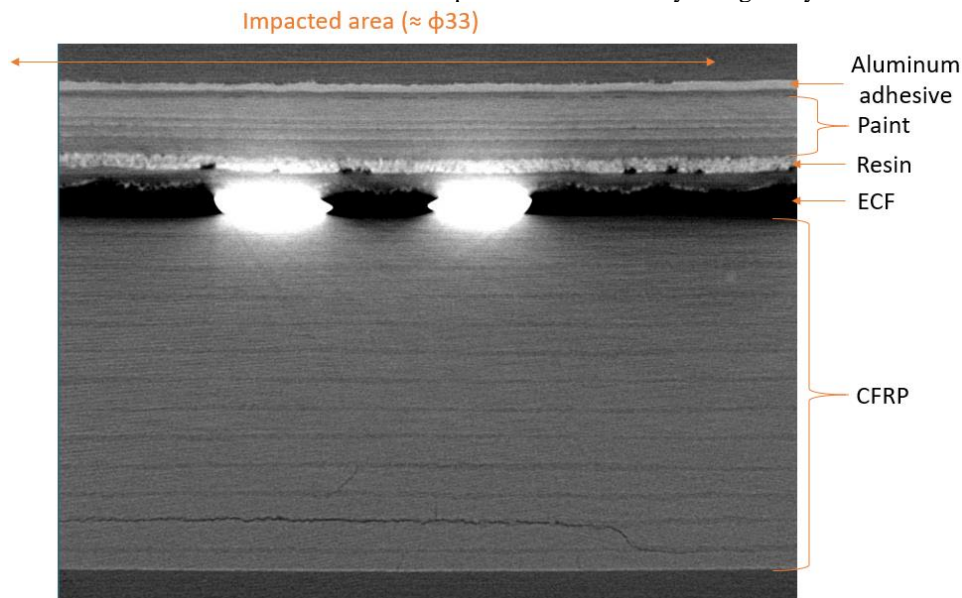
Figure 7 Microtomography cross section view of a post-mortem CCR+ECF+Paint sample submitted to a laser shot with a 1-centimeter thick glass confinement and a flux of approximately- 4.68 GW.cm⁻². Voxel size of 39.3 µm³.

The blisters seem to be due to a single delamination area as seen by the microtomography analysis of CFRP+ECF+Paint samples (Figure 7). Both of these samples used the maximum power configuration of the laser experimental setup, with a glass confinement. The microtomography view also shows a few transverse cracks in the last four plies that might be due to the combination of the bending of the sample under the shock.

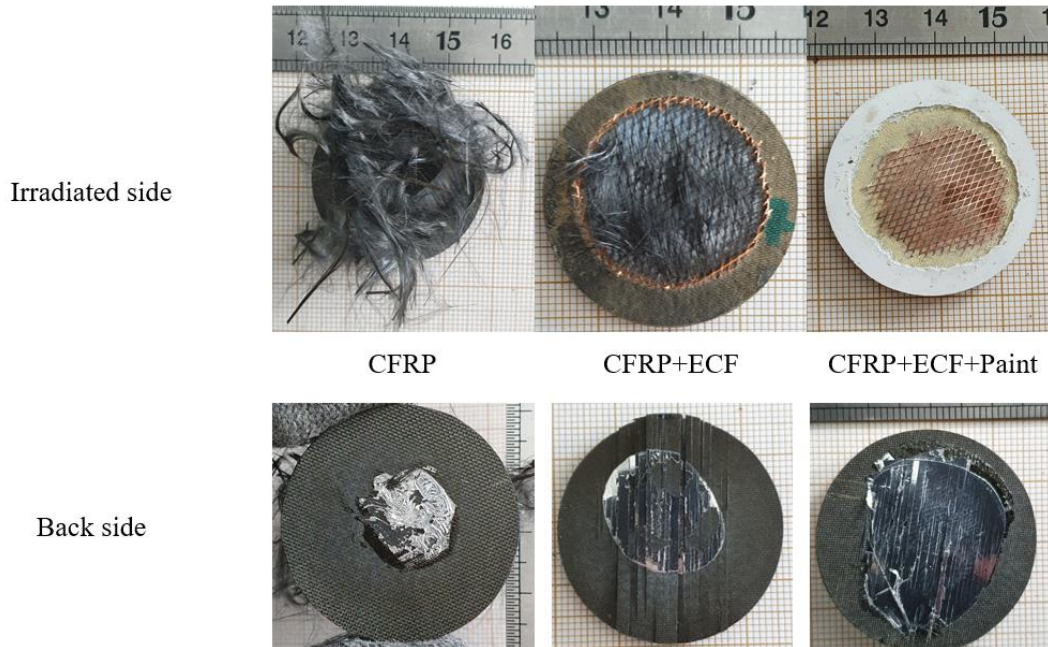
Figure 8 Post-mortem samples exposed to the STAEL electron beam at medium fluence (25 cal.cm^{-2}) for each coating.

Both low (15 cal.cm^{-2}) and medium (25 cal.cm^{-2}) fluences were studied with the electron beam. The results show a decrease of the surface damage with each added coating as presented in Figure 8 for 3 shots at medium fluence. Conversely the back-face damage increases with each added coating. The coating seems to act as a confinement for the thermal shock produced by the isochorous heating of the matter driven by the electron beam deposition.

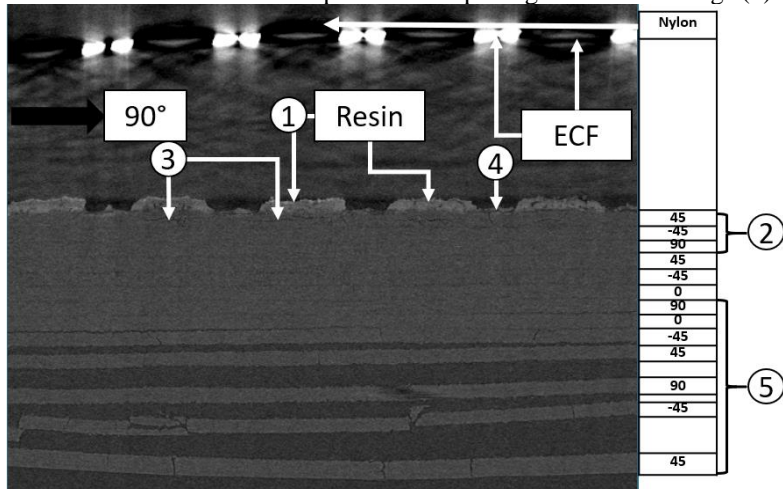
Figure 9 Microtomography local cross section view of a CFRP+ECF+Paint sample subjected to the STAEL electron beam at medium fluence. A nylon string is used to materialize the center of the front face. Voxel size of $64 \mu\text{m}^3$.

The internal damages of the samples are analyzed using a microtomography as seen in Figure 9. The results depict two different damage area: the surface damage where the paint is sublimated and the ECF is untied from the resin and the back-face damage with damage due to mechanical effects with delamination and spalling. Contrary to the other coatings, only the paint has been sublimated. The ECF has been blistered while the resin around the ECF stuck to the CFRP (1 in Figure 9). The first plies (2) are undamaged contrary to the other coatings even if some cracks are visible beneath the resin (3) or in the resin where the ECF once stood (4). Conversely, with each added coating, the back-face damage is increased, from some delamination for the CFRP sample to multi spalling the other coatings (5).

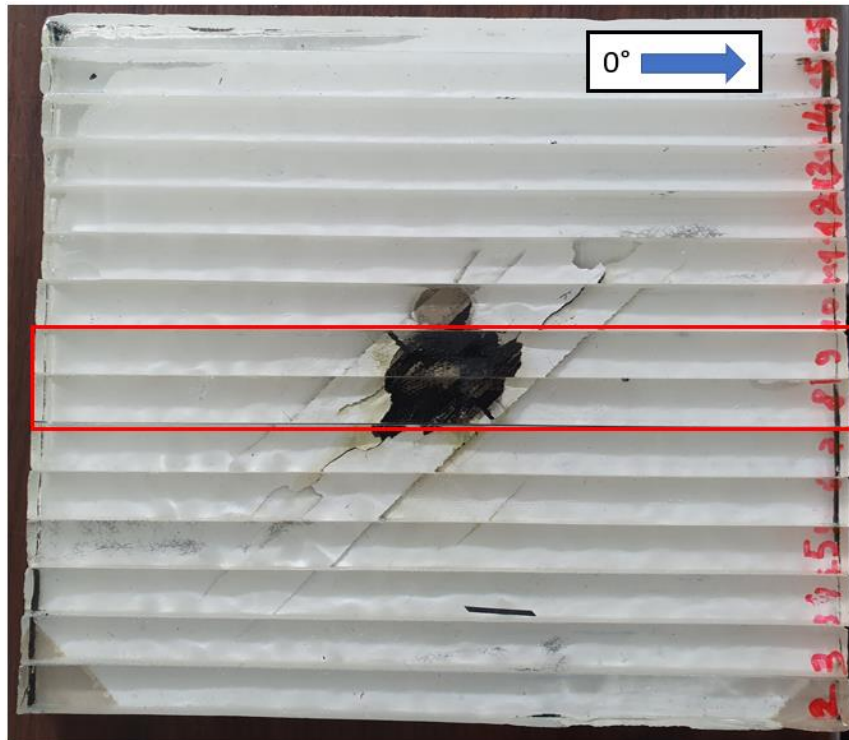
Figure 10 Post-mortem lightning strike CFRP+ECF+Paint sample coated in resin and cut for the microscopic analysis. Slices 8 and 9 framed in red.

The analysis of the lightning strike sample was made by coating the plate with resin to set the damage and by analyzing slices with a microscope (Figure 10). Due to the size of the plate, axis and peripheral damage are distinguished. The axis damage shows more surface damage with a mostly sublimated paint, ECF and resin and less core damage than in the peripheral area. The axis damage seems more linked to heat science and electromagnetics than mechanics contrary to the peripheral damage. The core damage of the peripheral area includes delamination of plies of the front and back-face as well as out of plane failure in the core.

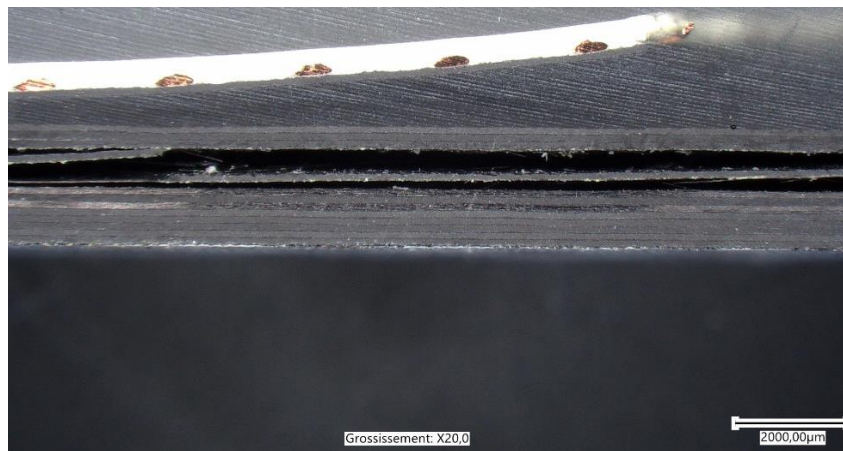
Figure 11 Microscopic view of the cross section in the rim of the lightning strike impact between slices 8 and 9.
