In-situ EBSD investigation of thermal stability of a 316L stainless steel nanocrystallized by surface mechanical attrition treatment

Y. Wu¹, Z. Sun¹, F. Brisset², T. Baudin², A.L. Helbert², D. Retraint^{1*}

Abstract

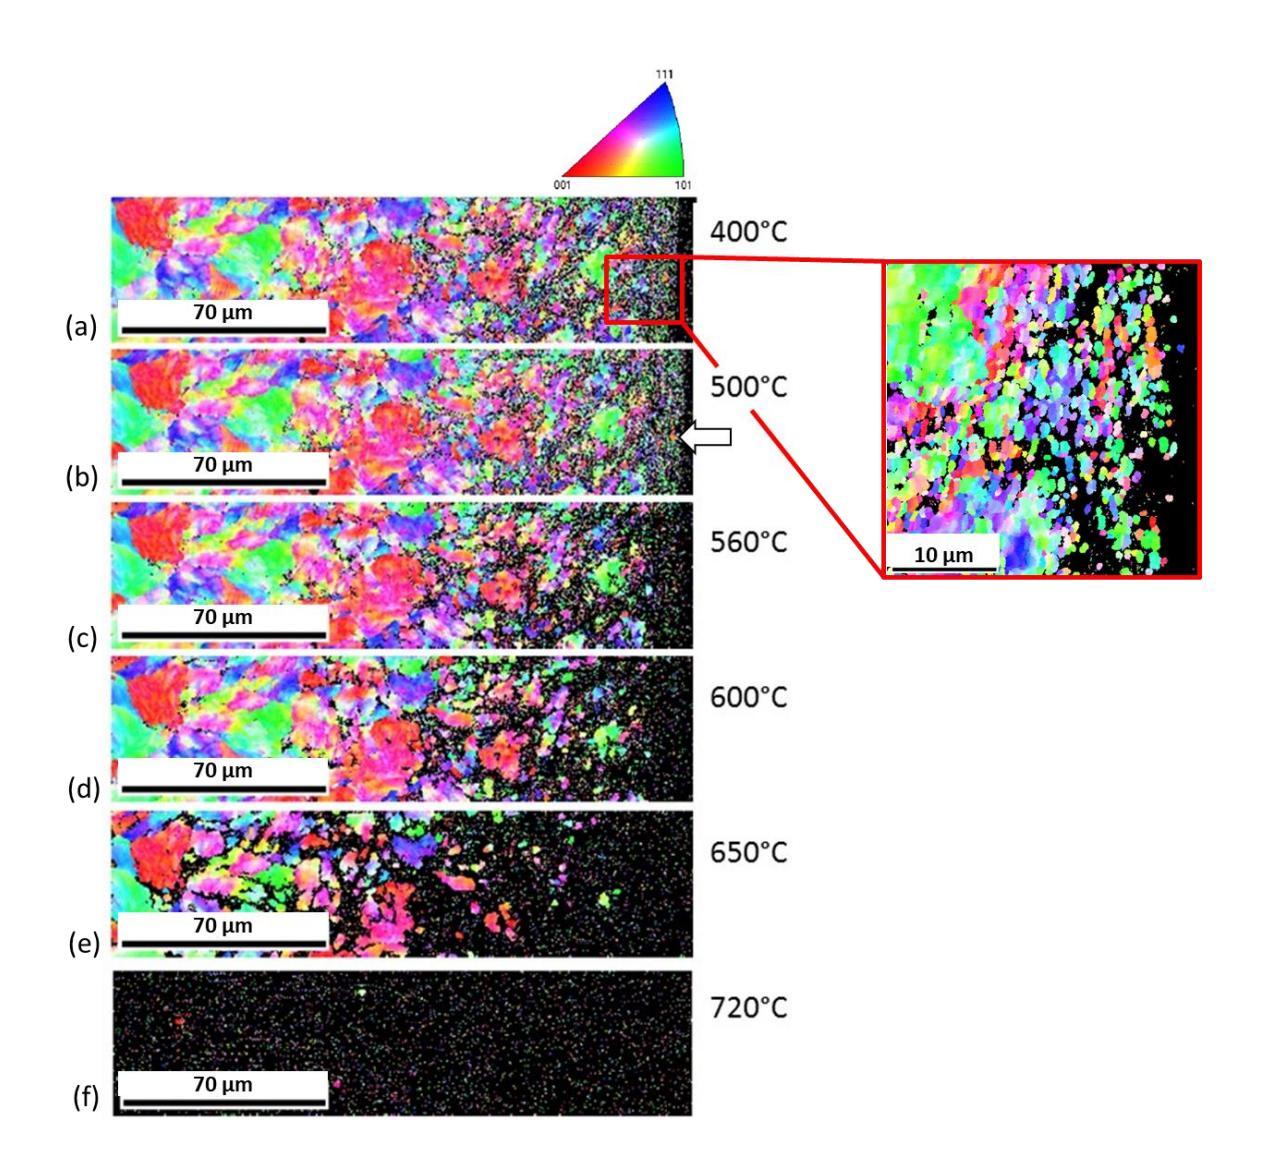
Figure 1 – EBSD maps from (a) to (f) show microstructure at different temperatures. The appearance of dark areas signifies a progressive degradation of indexation quality, especially for the treated surface (indicated by an arrow).

Fig. 1 illustrates the obtained maps for temperatures from 400°C to 720°C. It can be seen that with an increase of temperature, some areas become dark (Figs. 1b to 1e), which means that these areas are no longer well indexed due to the degradation of the Kikuchi diagram quality. This phenomenon is more significant in the areas with small grains, especially in the nanostructured layer. At 720°C, the indexation is totally lost (Fig. 1f).

The observed heterogeneous oxidation can be related to the poor oxidation resistance of fine grained materials. As a matter of fact, in the region where the grain size is small, the fraction of grain boundaries is relatively high. It is well known that at grain boundaries, the atomic arrangement is less regular. Grain boundaries can thus provide short circuit diffusion path for oxygen to penetrate more easily into the material. Oxidation preferably begins at the SMATed surface where grain boundary density is high and extends to the bulk where the diffusion kinetics is relatively low. In the case of austenitic stainless steels, another mechanism can be involved in the oxidation process. When these steels are heated to 425-815°C, chromium carbides can form at grain boundaries. As a result, the narrow areas adjacent to the grain boundaries are highly depleted in chromium and oxidation may easily occur there [14, 15]. It

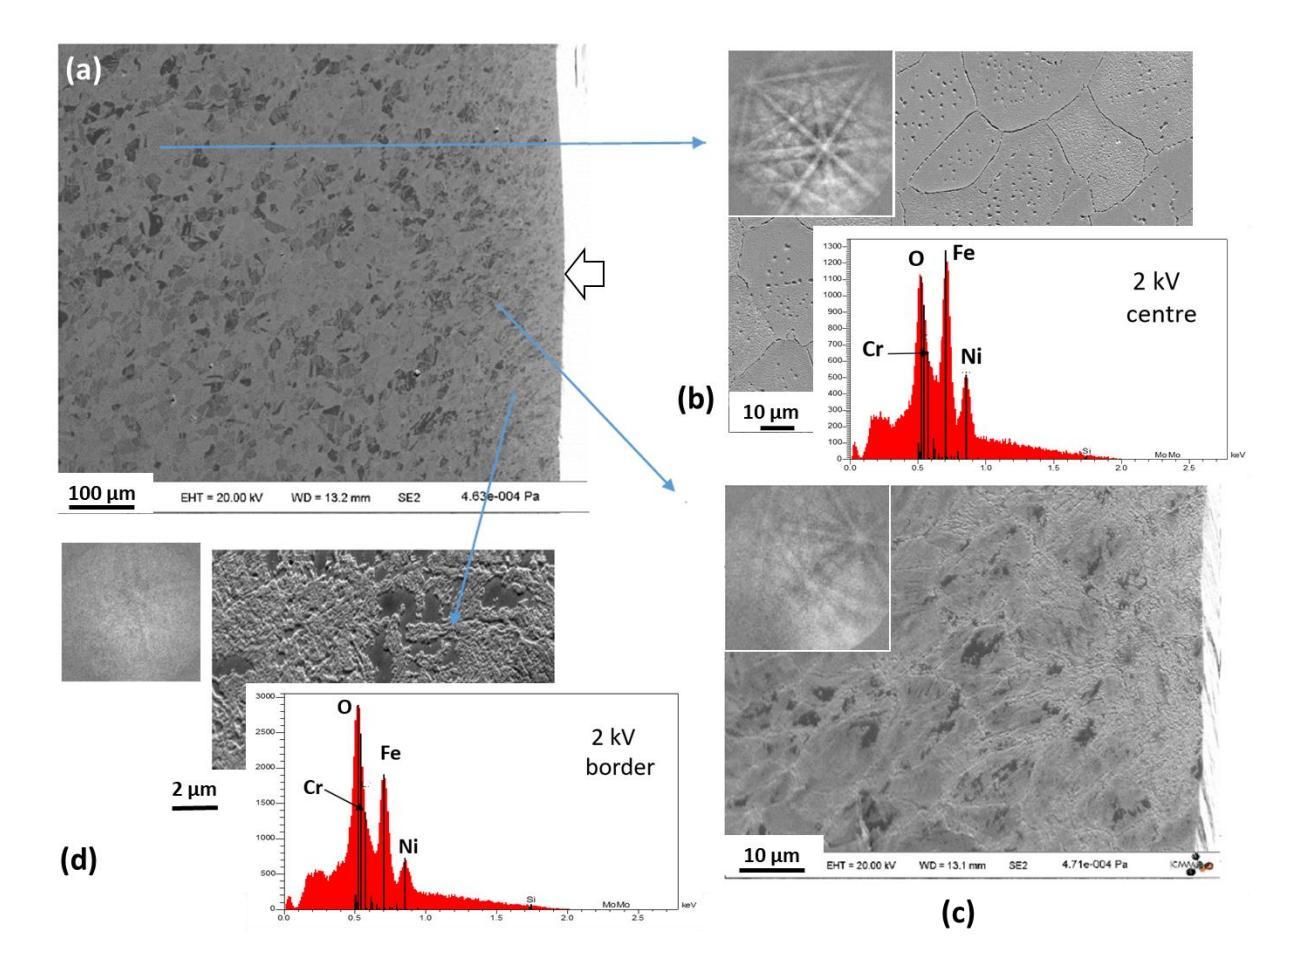
Figure 2 – Micrographs obtained after heating up to 720°C and cooling, EDS analyses and Kikuchi
diffraction patterns: (a) global view of a large region (the arrow indicates the surface), (b) bulk region,
(c) strongly work-hardened region, and (d) very near surface region.

Fig. 2 presents some characteristic areas after a thermal exposure at 720°C and cooling down to room temperature. As it can be seen, all areas give rise to Kikuchi diagrams with more or less acceptable quality, which indicates that over a certain temperature, electron diffraction is deteriorated. From 560°C to 650°C, a loss of Kikuchi pattern quality occurs at grain boundaries (Fig. 1) and especially at the SMATed surface. According to Fig. 2d, this loss of indexation quality is due to an oxidation effect, as indicated by the Energy Dispersive X-ray Spectrometry (EDS) analysis. This phenomenon occurs more easily on small grains. It seems strange that the sample is oxidized even in a secondary vacuum (around 10⁻¹⁰ atm), i.e. the working condition of a conventional SEM. In fact, according to the Ellingham diagram [13], chromium oxide can be formed at 500°C even when the pressure of oxygen is as low as 10⁻⁴² atm. However, the oxidation kinetics is guite low at 500°C and the temperature holding is not long enough to notice any significant changes in the indexation quality (see Fig. 1b). That is why a noticeable indexation quality degradation can be observed only beyond 560°C (Fig. 1c). Fig. 2a shows an oxidation gradient from the surface to the centre of the sample. In the transition area where the alloy was strongly plastically deformed, oxidation takes place and the indexation quality is degraded (Fig. 2c). Finally, in the area far from the surface, the material is subjected to thermal grooving while the oxidation level remains low: the indexation quality remains thus good (Fig. 2b). Note that the thermal grooving of grain boundaries is observed from 600°C.

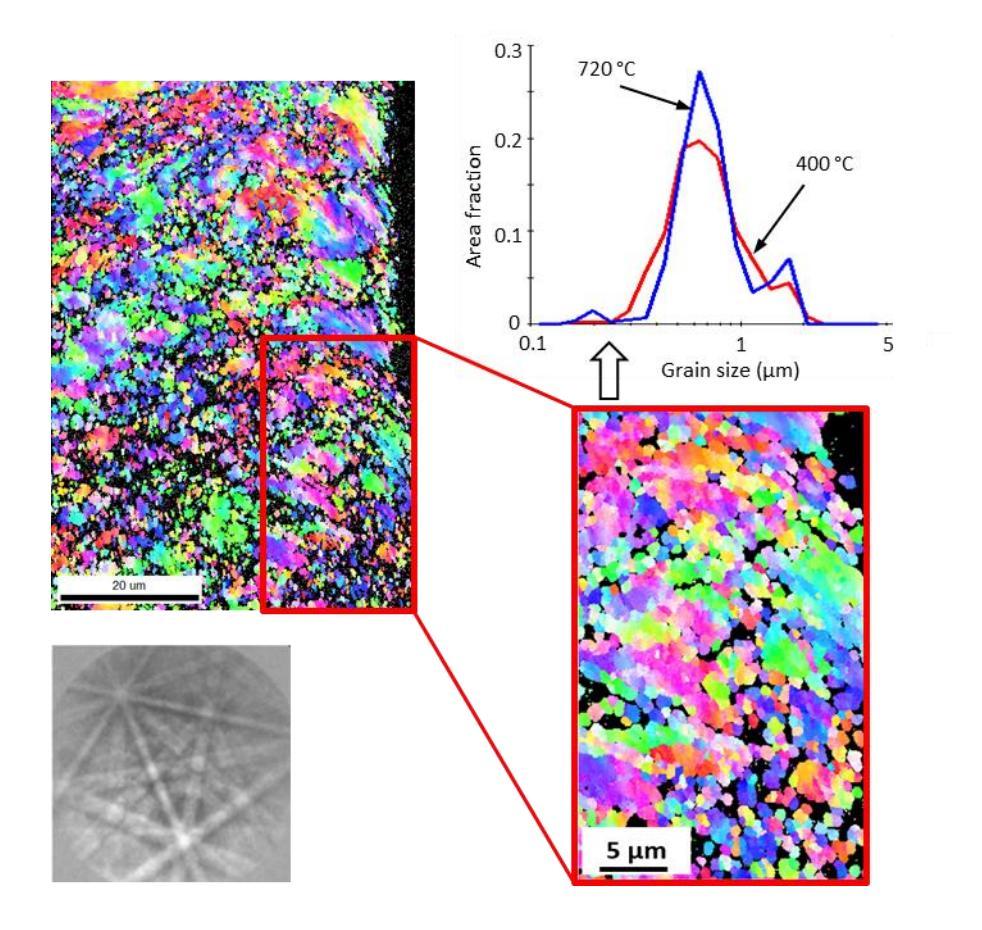
Figure 3 – EBSD observation performed after the removal of the oxidized layer (720°C) using ionic polishing. Ultrafine grain size distribution at the SMATed surface for both 400 and 720°C.

Contrary to what was initially expected, the microstructure evolution is negligible despite the presence of areas with high stored energy favorable for recrystallization and grain growth. As thermal grooving and oxidation can both hamper the grain boundary migration at the surface, it was decided to verify the microstructure under the oxidized surface. Ionic polishing was therefore carried out a posteriori on the sample heated at 720°C to remove the oxidized layer. After ionic polishing, the indexation quality became much better according to the Kikuchi diffraction pattern shown in Fig. 3. The microstructure looks very similar to that obtained after SMAT, and no notable change in grain size (Fig. 3) and misorientation is observed according to the analyses of the obtained cartographies. This means that the microstructure is not obviously changed by the temperature. The ultrafine grain size remains constant at $0.7\mu m +/-0.2\mu m$. This investigation is consistent with the results presented in the literature concerning
